“Full” Reserve Study

Lake Forest Home Association Lacey, WA

Report #: 29010-0

Date Prepared: September 24, 2015

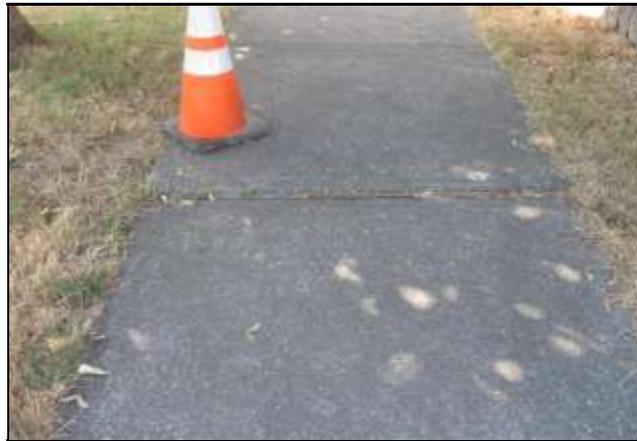
Comp # : 100 Concrete - Repair/Replace Quantity: ~ 29,000 Sq Ft
Location : Sidewalks at Lake Forest Drive, Marquette Drive and Oxford Drive; walks/steps at lake park
Funded? : Yes

Evaluation : Although the majority of concrete appeared in fair condition, we observed a couple of areas where the walkways have shifted (see photo below) as well as some scattered areas of cracking and deterioration.

Useful Life:
5 years

Remaining Life:
0 years

Due to current condition and typical ongoing wear, we suggest a funding allowance to supplement the operating budget for periodic larger scale repair/replacements as reflected below.

As routine maintenance, inspect regularly and pressure wash for appearance. Repair any trip hazards (1/2" difference in height) immediately to ensure safety. Repair cracks promptly as needed to prevent water penetrating into the base, which can cause further damage. Factors affecting the quality of the concrete include; the preparation of the underlying soil and drainage, thickness and strength of concrete used, steel reinforcement (none likely).

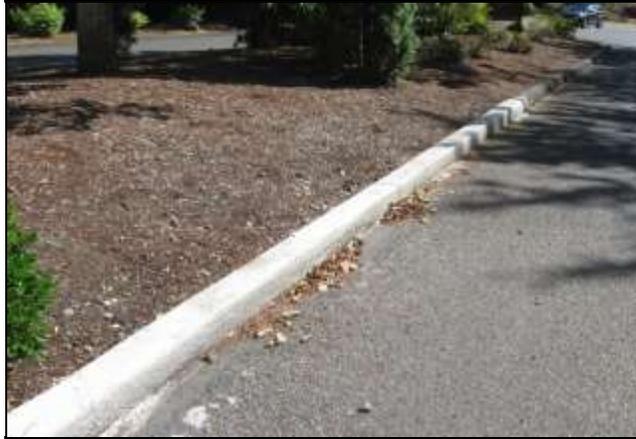
Comp # : 102 Concrete Curb - Repair/Replace Quantity: ~ 240 Lin Ft

Funded? : No Useful life not predictable, repair/replace as needed out of operating budget

History : Recently repaired

Evaluation : We noted curbing to be in generally good condition and appearance with no significant damage.

No predictable expectation for large scale replacement at this time, no reserve funding suggested. Repair/replace as needed as part of previous component or through operating budget.

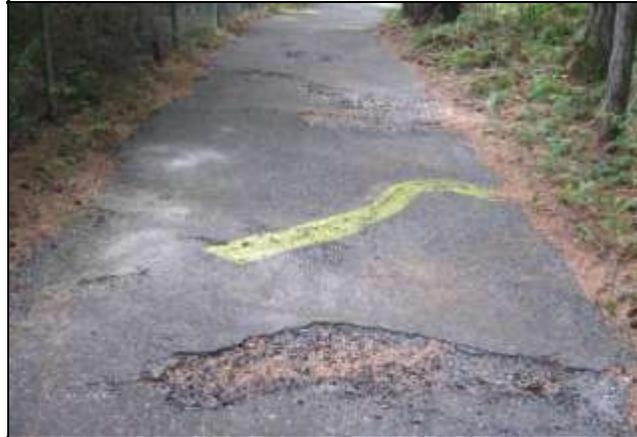
Evaluation : Areas of deterioration and tree root damage observed throughout asphalt pathway.

Useful Life:
30 years

Remaining Life:
0 years
